**Massachusetts Bay
Transportation Authority**

Blue Line Program

October 1, 2018

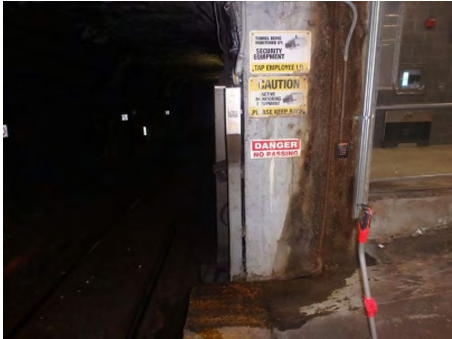
Leakage and corrosion at Maverick Platform

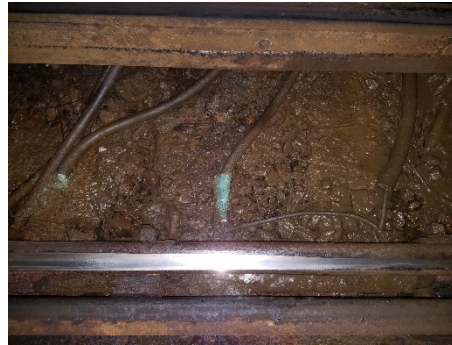
Corroded cables due to water at Maverick

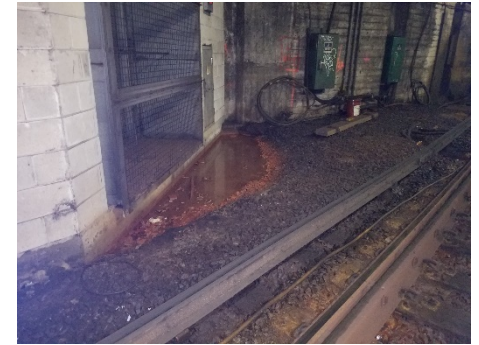
Standing puddle of water at Maverick

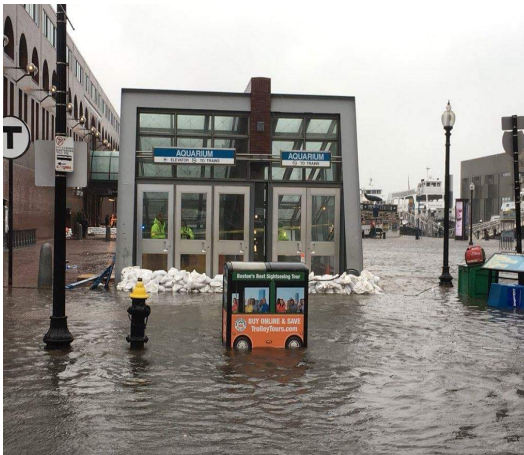
Flooding at Aquarium Station

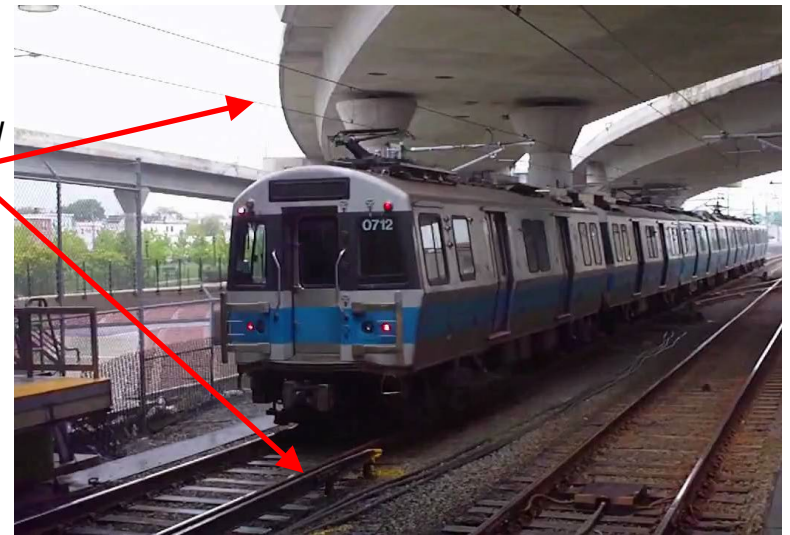
*3rd Rail + Overhead
Catenary Power*

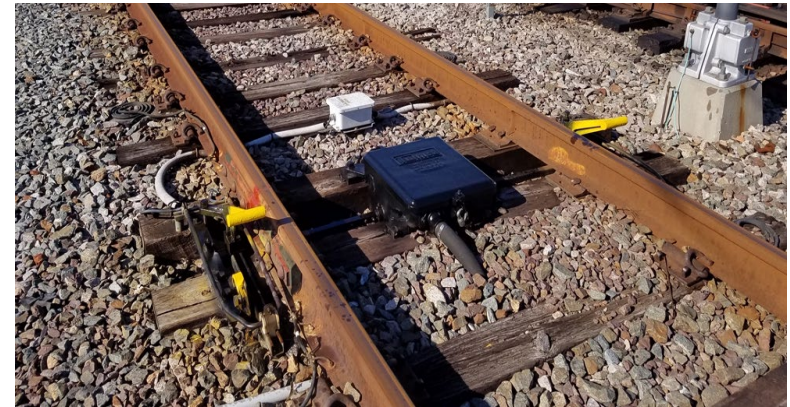
Mechanical Trip Stop in the "stop" position
